**Flood Control Project Maintenance
Levee Inspections**
LMA District Cover Sheet
Spring 2018 Levee Inspection Results

Reclamation District No. 0999 Netherlands

Spring 2018 Levee Inspection Results

Waterway			Bank	Unit Miles
Unit No. 01 Yolo Bypass			Left	15.41
	Spring (March - May)	Summer (June - August)	(September - November) Fall	Winter (December - February)
Unit Maintenance Rating (Fall Only)				
Date of Inspection	5/8/2018 - 5/8/2018			
DWR Inspector	Dave Torres			
Accompanied By	Tom Slater RD999

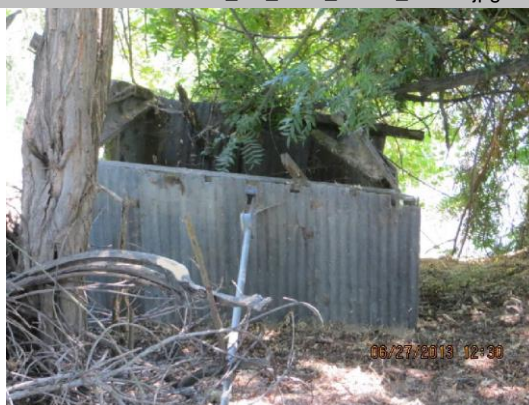
Photo 1 of 2 : UCIP_SP_2018_15450_25386.jpg

LM Start	0.72	Rating **	M	Issue No.	232
LM End	0.72	Issue Type +	En	Location *	
Category	Supplemental			GPS Latitude/Longitude	
				Start	End
Item	DWR UCIP Field Study			38.342653 °	38.342653 °
				-121.581236 °	-121.581236 °
DWR ID					
Comment Code					
Inspector Comment					
FS_ID:15450 DS_ID:22842 EP_NO: N/A Repair Type: Non-Urgent Crossing Status: Found UCIP Comments: Pipe abandoned and should be done so properly. FIELD_STRUCT_DESC: *ABANDONED* 6-inch steel irrigation pipe through the levee, 11.5 feet below the crown. Pump and gate valve in pump house on the waterside (WS) slope. 1.5-inch galvanized iron electrical conduit at the same location. [Additional Reference(s): DWR Levee Log, 1992. USACE Sacramento O&M Manual 113 (Revised), October 1966, (HLM 0.75)]. FS Date: 6/27/2013

Pumphouse on WS slope with electrical conduit shown.

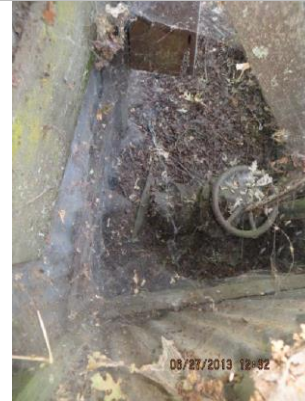
Photo 2 of 2 : UCIP_SP_2018_15450_25385.jpg

LM Start	0.72	Rating **	M	Issue No.	232 (cont)	
LM End	0.72	Issue Type +	En	Location *		
Category	Supplemental			GPS Latitude/Longitude		
				Start	End	
Item	DWR UCIP Field Study			38.342653 °	38.342653 °	
				-121.581236 °	-121.581236 °	
DWR ID						
Comment Code						
Inspector Comment						
FS_ID:15450 DS_ID:22842 EP_NO: N/A Repair Type: Non-Urgent Crossing Status: Found UCIP Comments: Pipe abandoned and should be done so properly. FIELD_STRUCT_DESC: *ABANDONED* 6-inch steel irrigation pipe through the levee, 11.5 feet below the crown. Pump and gate valve in pump house on the waterside (WS) slope. 1.5-inch galvanized iron electrical conduit at the same location. [Additional Reference(s): DWR Levee Log, 1992. USACE Sacramento O&M Manual 113 (Revised), October 1966, (HLM 0.75)]. FS Date: 6/27/2013

Pipe rusted through at gatevalve inside pumphouse.

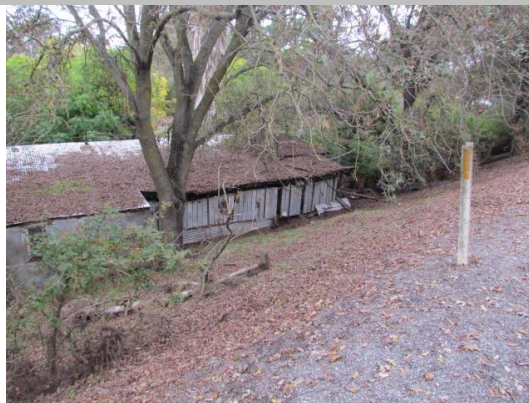
Photo 2 of 2 : SP_2018_RD0999_236_23_20180301_00020.jpg

LM Start	0.77	Rating **	U	Issue No.	23 (cont)	
LM End	0.77	Issue Type +	En	Location *	LS	
Category	Earthen Levee			GPS Latitude/Longitude		
				Start	End	
Item	Encroachments			38.343358 °	38.343358 °	
				-121.581295 °	-121.581295 °	
DWR ID	DWR_RD0999_05_f_2012_23					
Comment Code						
BU : Building						
Inspector Comment						
Storage shed at landside toe and within the 10' easement.

Looking northwest at storage shed at landside toe and within the 10' easement.

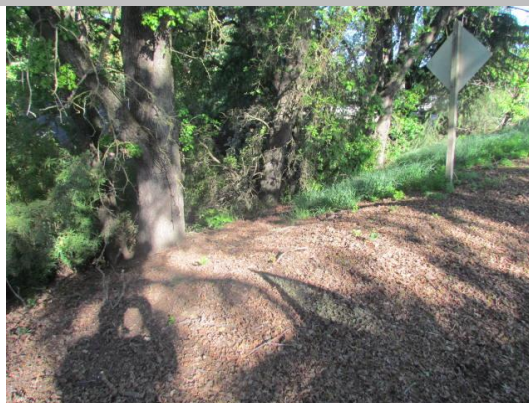
Photo 1 of 2 : SP_2018_RD0999_236_128_20180301_00061.jpg

LM Start	0.78	Rating **	M	Issue No.	128
LM End	0.79	Issue Type +	Ma	Location *	LS
Category	Earthen Levee			GPS Latitude/Longitude	
				Start	End
Item	Trim / Thin Trees			38.343495 °	38.343617 °
				-121.581282 °	-121.581249 °
DWR ID	DWR_RD0999_05_s_2012_128				
Comment Code					
T3 : Trim and thin trees to allow visibility of the ground and room to flood fight.					
Inspector Comment

Looking northwest at untrimmed trees on landward slope. (Spring 2015)

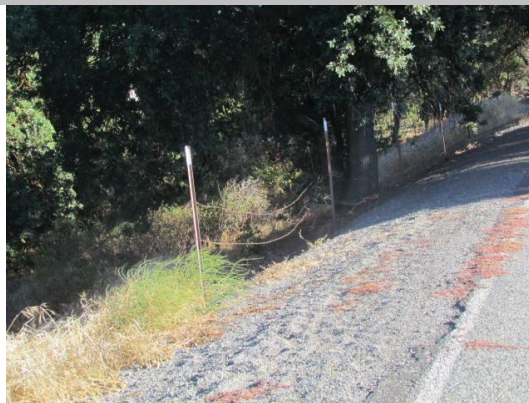
Photo 1 of 1 : SP_2018_RD0999_236_136_20180301_00065.jpg

LM Start	0.96	Rating **	M	Issue No.	136
LM End	1.02	Issue Type +	En	Location *	LS
Category	Earthen Levee			GPS Latitude/Longitude	
				Start	End
Item	Encroachments			38.346016 °	38.346861 °
				-121.580358 °	-121.579853 °
DWR ID	DWR_RD0999_05_f_2013_136				
Comment Code					
FE : Fence					
Inspector Comment					
Fencing on landside slope.

Looking northwest at fence on landward slope.

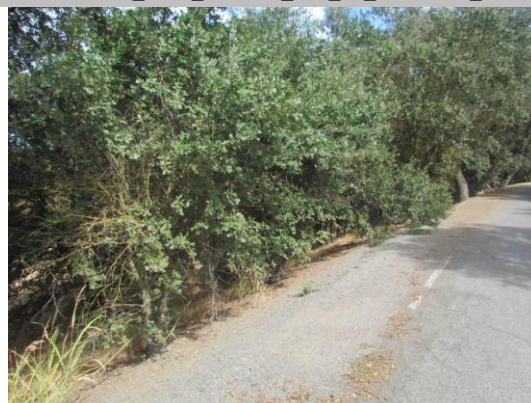
Photo 1 of 1 : SP_2018_RD0999_236_14_20180301_00011.jpg

LM Start	1.07	Rating **	M	Issue No.	14
LM End	1.11	Issue Type +	Ma	Location *	LS
Category	Earthen Levee			GPS Latitude/Longitude	
				Start	End
Item	Trim / Thin Trees			38.347427 °	38.347863 °
				-121.579395 °	-121.579113 °
DWR ID	DWR_RD0999_05_s_2012_14				
Comment Code					
T1 : Trim trees to at least five feet above ground level.					
Inspector Comment

Looking west at untrimmed trees on landward slope and toe.

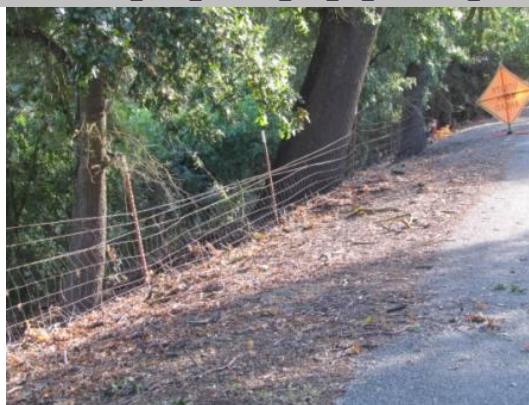
Photo 1 of 1 : SP_2018_RD0999_236_76_20180301_00040.jpg

LM Start	1.20	Rating **	M	Issue No.	76
LM End	1.22	Issue Type +	En	Location *	LS
Category	Earthen Levee			GPS Latitude/Longitude	
				Start	End
Item	Encroachments			38.348336 °	38.348332 °
				-121.577621 °	-121.577172 °
DWR ID	DWR_RD0999_05_s_2012_76				
Comment Code					
FE : Fence					
Inspector Comment					
Fence is located on landside shoulder.

Looking north at fence along landside slope.

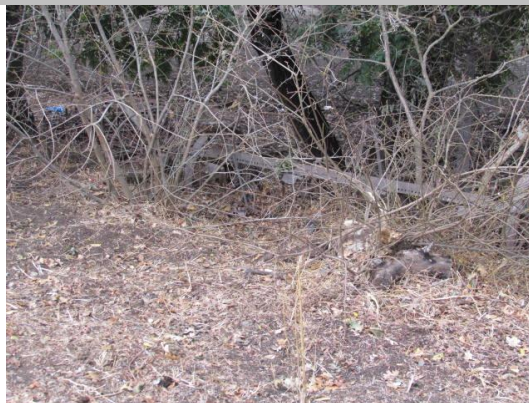
Photo 1 of 1 : SP_2018_RD0999_236_171_20180301_00091.jpg

LM Start	1.25	Rating **	M	Issue No.	171
LM End	1.25	Issue Type +	En	Location *	LS
Category	Earthen Levee			GPS Latitude/Longitude	
				Start	End
Item	Encroachments			38.348319 °	38.348319 °
				-121.576566 °	-121.576566 °
DWR ID	DWR_RD0999_05_f_2015_171				
Comment Code					
EQ : Equipment					
Inspector Comment					
Old farm equipment on landside slope

Looking at farm equipment on landward slope.

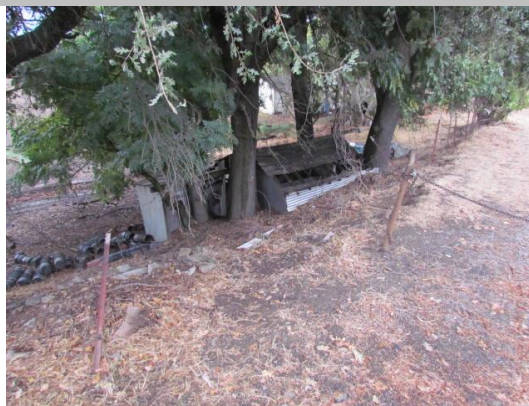
Photo 1 of 3 : SP_2018_RD0999_236_172_20180301_00092.jpg

LM Start	1.27	Rating **	U	Issue No.	172
LM End	1.27	Issue Type +	En	Location *	LS
Category	Earthen Levee			GPS Latitude/Longitude	
				Start	End
Item	Encroachments			38.348304 °	38.348304 °
				-121.576207 °	-121.576207 °
DWR ID	DWR_RD0999_05_f_2015_172				
Comment Code					
BU : Building					
Inspector Comment					
Toolshed excavated into landside toe.

Looking southwest at toolshed at landward toe.

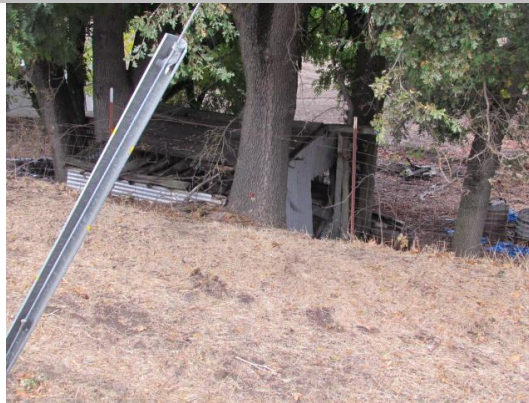
Photo 3 of 3 : SP_2018_RD0999_236_172_20180301_00094.jpg

LM Start	1.27	Rating **	U	Issue No.	172 (cont)	
LM End	1.27	Issue Type +	En	Location *	LS	
Category	Earthen Levee			GPS Latitude/Longitude		
				Start		End
Item	Encroachments			38.348304 °		38.348304 °
				-121.576207 °		-121.576207 °
DWR ID	DWR_RD0999_05_f_2015_172					
Comment Code						
BU : Building						
Inspector Comment						
Toolshed excavated into landside toe.

Looking at northwest at toolshed at landward toe.

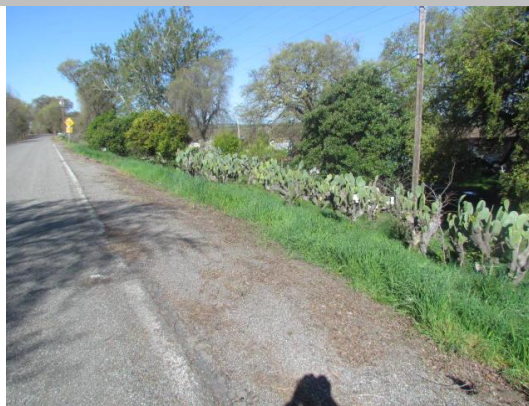
Photo 1 of 4 : SP_2018_RD0999_236_2_20180301_00001.jpg

LM Start	1.28	Rating **	U	Issue No.	2
LM End	1.28	Issue Type +	En	Location *	LS
Category	Earthen Levee			GPS Latitude/Longitude	
				Start	End
Item	Vegetation			38.348279 °	38.348279 °
				-121.576061 °	-121.576061 °
DWR ID	DWR_RD0999_05_s_2012_2				
Comment Code					
V6 : Landscaping					
Inspector Comment					
Century plant on landside shoulder.

Looking southwest at dense cactus plants on landward slope and toe.

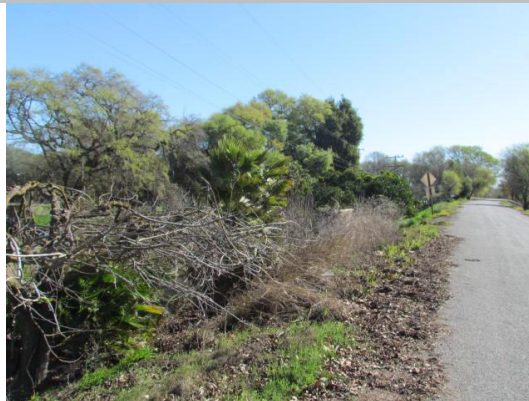
Photo 2 of 4 : SP_2018_RD0999_236_2_20180301_00002.jpg

Looking south at landscaping on landward slope.

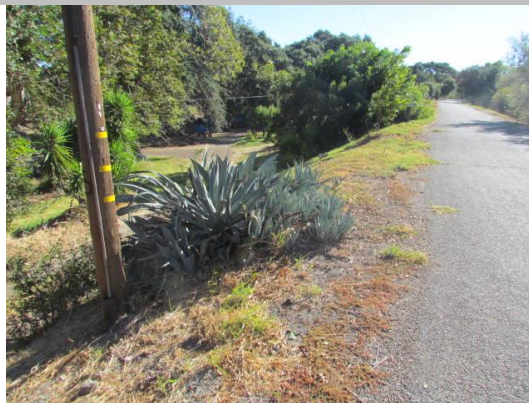
Photo 3 of 4 : SP_2018_RD0999_236_2_20180301_00003.jpg

LM Start	1.28	Rating **	U	Issue No.	2 (cont)	
LM End	1.28	Issue Type +	En	Location *	LS	
Category	Earthen Levee			GPS Latitude/Longitude		
				Start		End
Item	Vegetation			38.348279 °		38.348279 °
				-121.576061 °		-121.576061 °
DWR ID	DWR_RD0999_05_s_2012_2					
Comment Code						
V6 : Landscaping						
Inspector Comment						
Century plant on landside shoulder.

Looking northwest at landscaping on landward slope.

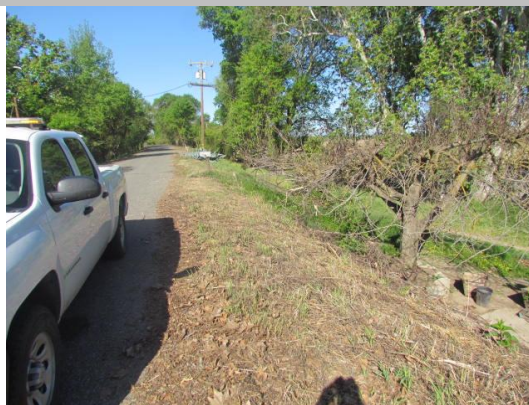
Photo 4 of 4 : SP_2018_RD0999_236_2_20180301_00004.jpg

Looking south at landward slope. (Spring 2015)

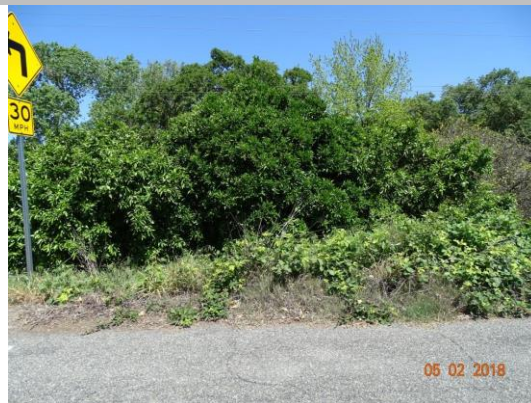
Photo 1 of 1 : SP_2018_RD0999_236_13_20180507_00201.jpg

LM Start	1.32	Rating **	U	Issue No.	13
LM End	1.32	Issue Type +	En	Location *	LS
Category	Earthen Levee			GPS Latitude/Longitude	
				Start	End
Item	Vegetation			38.348226 °	38.348226 °
				-121.575399 °	-121.575399 °
DWR ID	DWR_RD0999_05_s_2018_13				
Comment Code					
V6 : Landscaping					
Inspector Comment

Vegetation landside looking west.

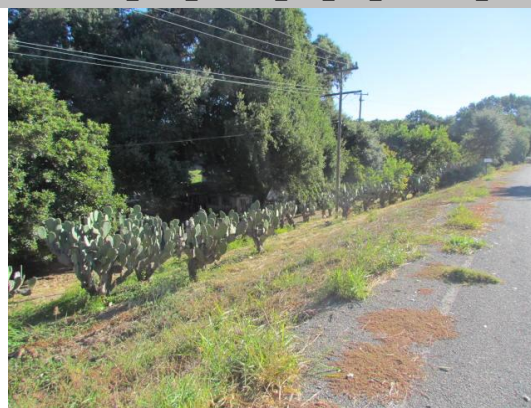
Photo 1 of 1 : SP_2018_RD0999_236_149_20180301_00069.jpg

LM Start	1.33	Rating **	M	Issue No.	149
LM End	1.36	Issue Type +	En	Location *	LS
Category	Earthen Levee			GPS Latitude/Longitude	
				Start	End
Item	Vegetation			38.348223 °	38.348191 °
				-121.575223 °	-121.574667 °
DWR ID	DWR_RD0999_05_f_2013_149				
Comment Code					
V6 : Landscaping					
Inspector Comment					
Large cactus plants on landside slope.

Looking northwest at several cactus plants on landward slope.

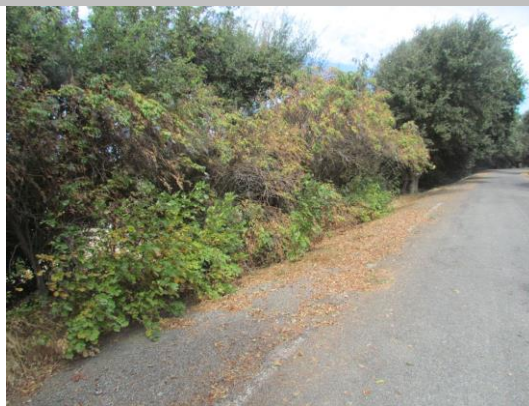
Photo 1 of 1 : SP_2018_RD0999_236_199_20180301_000109.jpg

LM Start	1.69	Rating **	U	Issue No.	199
LM End	1.69	Issue Type +	Ma	Location *	LS
Category	Earthen Levee			GPS Latitude/Longitude	
				Start	End
Item	Vegetation			38.351957 °	38.351957 °
				-121.574096 °	-121.574096 °
DWR ID	DWR_RD0999_05_f_2014_199				
Comment Code					
V2 : Remove the wild growth other than native grasses from the levee slopes.					
Inspector Comment					
Dense vegetation on landward slope.

Looking northwest at dense vegetation on landward slope.

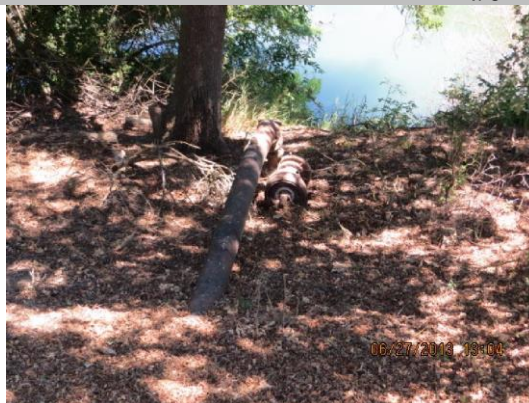
Photo 1 of 2 : UCIP_SP_2018_15421_25323.jpg

LM Start	1.83	Rating **	M	Issue No.	234
LM End	1.83	Issue Type +	En	Location *	
Category	Supplemental			GPS Latitude/Longitude	
				Start	End
Item	DWR UCIP Field Study			38.353864 °	38.353864 °
				-121.573577 °	-121.573577 °
DWR ID					
Comment Code					
Inspector Comment					
FS_ID:15421					
DS_ID:22847					
EP_NO: N/A					
Repair Type: Non-Urgent					
Crossing Status: Found					
UCIP Comments: Abandoned and should be done so properly.					
FIELD_STRUCT_DESC: *ABANDONED* 8-inch steel irrigation pipe					
through the levee, 4.7 feet below the crown. Pump house on the					
waterside (WS) slope. Both ends open. [Additional Reference(s): DWR					
Levee Log, 1992. USACE Sacramento O&M Manual 113 (Revised),					
October 1966, (HLM 1.89)].					
FS Date: 6/27/2013

Pipe and pump remnants on WS slope.

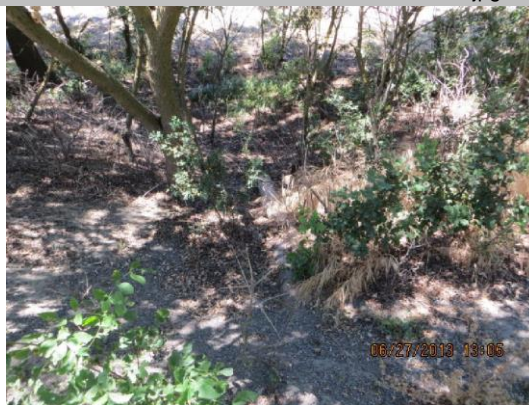
Photo 2 of 2 : UCIP_SP_2018_15421_25322.jpg

Pipe visible on LS slope.

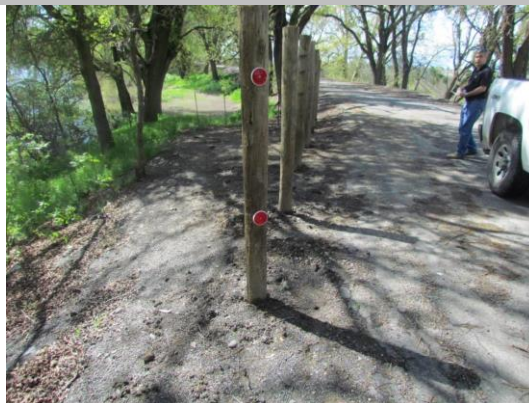
Photo 1 of 3 : SP_2018_RD0999_236_167_20180301_00086.jpg

LM Start	2.00	Rating **	A/W	Issue No.	167 (cont)
LM End	2.00	Issue Type +	En	Location *	WS

Looking downstream at wooden poles on waterward shoulder.

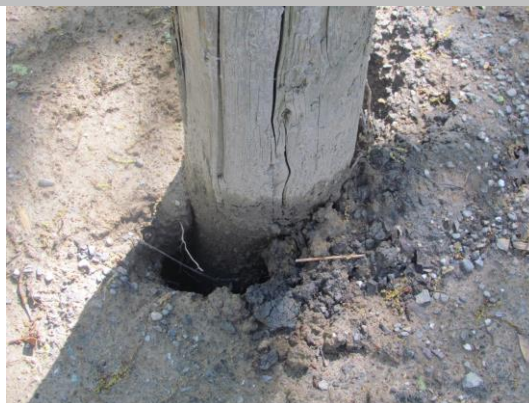
Photo 3 of 3 : SP_2018_RD0999_236_167_20180301_00088.jpg

Looking at 3-4 ft hole for pole on waterward shoulder.

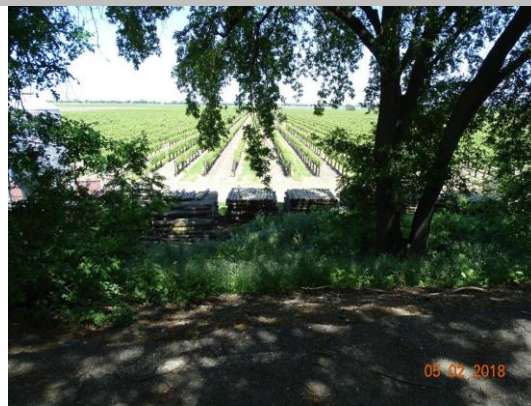
Photo 1 of 1 : SP_2018_RD0999_236_67_20180507_00202.jpg

LM Start	2.05	Rating **	M	Issue No.	67
LM End	2.05	Issue Type +	En	Location *	LS
Category	Earthen Levee			GPS Latitude/Longitude	
				Start	End
Item	Encroachments			38.355637 °	38.355637 °
				-121.570442 °	-121.570442 °
DWR ID	DWR_RD0999_05_s_2018_67				
Comment Code					
EQ : Equipment					
Inspector Comment					
Landowner has stored poles at landside toe.

Encroachment poles landside looking northwest.

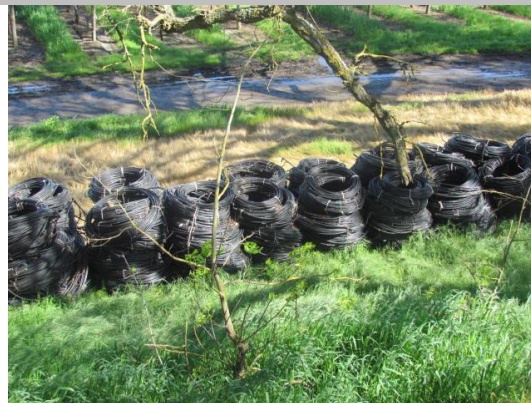
Photo 1 of 1 : SP_2018_RD0999_236_212_20180301_00115.jpg

LM Start	2.09	Rating **	M	Issue No.	212
LM End	2.09	Issue Type +	En	Location *	LS
Category	Earthen Levee			GPS Latitude/Longitude	
				Start	End
Item	Encroachments			38.355673 °	38.355673 °
				-121.569794 °	-121.569794 °
DWR ID	DWR_RD0999_05_s_2016_212				
Comment Code					
EQ : Equipment					
Inspector Comment					
Farmer has stored black sprinkler lines at landside toe.

Looking south at black sprinkler lines at landward toe.

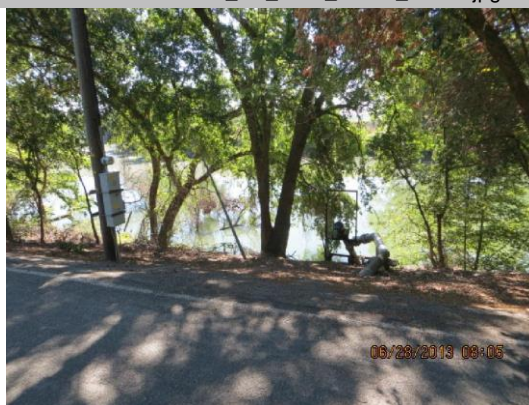
Photo 1 of 3 : UCIP_SP_2018_50093_25332.jpg

LM Start	3.02	Rating **	U	Issue No.	235	
LM End	3.02	Issue Type +	En	Location *		
Category	Supplemental			GPS Latitude/Longitude		
				Start	End	
Item	DWR UCIP Field Study			38.363420 °	38.363420 °	
				-121.563102 °	-121.563102 °	
DWR ID

Comment Code						
Inspector Comment						
FS_ID:50093 DS_ID:22849 EP_NO: 7378 Repair Type: Urgent Crossing Status: Found UCIP Comments: 07/07/2016 - LS toe of levee still has erosion around stand pipe and adjacent oak tree. Erosion does not appear to be any worse than during previous inspection. no water in canal on LS toe led to the discovery of two additional appurtenant structures. (T. Hatch/UCIP)06/28/2013 - Pipe outlet is eroding the LS slope of the levee, exposing the roots of an oak and threatening greater damage if allowed to continue. (W. Wylie/UCIP) FIELD_STRUCT_DESC: 10-inch steel irrigation pipe through the levee, 6 feet below the crown. Slant pump and service pole on the waterside (WS) slope. 36-inch concrete standpipe on the landside (LS) toe. (Permit No. 7378, 1971 - Rudolph H. Volz. Replaced an existing 8-inch pipe at the same location). [Additional Reference(s): DWR Levee Log, 1992]. FS Date: 7/7/2016

Slant pump, JP, and meter on WS slope.

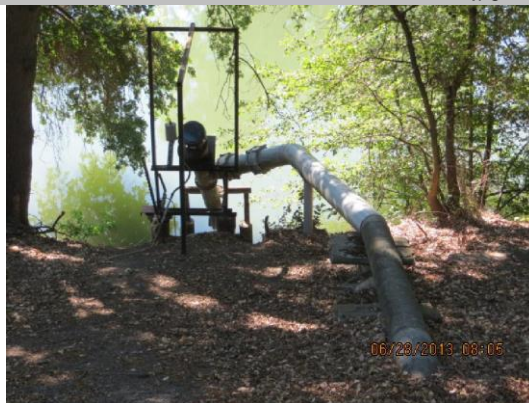
Photo 2 of 3 : UCIP_SP_2018_50093_25331.jpg

LM Start	3.02	Rating **	U	Issue No.	235 (cont)
LM End	3.02	Issue Type +	En	Location *

Slant pump and pipe on WS slope.

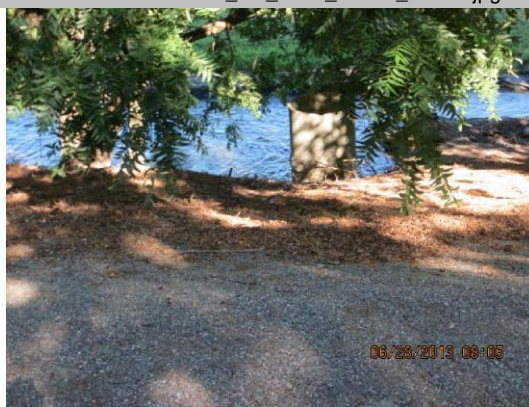
Photo 3 of 3 : UCIP_SP_2018_50093_25330.jpg

Comment Code						
Inspector Comment						
FS_ID:50093 DS_ID:22849 EP_NO: 7378 Repair Type: Urgent Crossing Status: Found UCIP Comments: 07/07/2016 - LS toe of levee still has erosion around stand pipe and adjacent oak tree. Erosion does not appear to be any worse than during previous inspection. no water in canal on LS toe led to the discovery of two additional appurtenant structures. (T. Hatch/UCIP)06/28/2013 - Pipe outlet is eroding the LS slope of the levee, exposing the roots of an oak and threatening greater damage if allowed to continue. (W. Wylie/UCIP) FIELD_STRUCT_DESC: 10-inch steel irrigation pipe through the levee, 6 feet below the crown. Slant pump and service pole on the waterside (WS) slope. 36-inch concrete standpipe on the landside (LS) toe. (Permit No. 7378, 1971 - Rudolph H. Volz. Replaced an existing 8-inch pipe at the same location). [Additional Reference(s): DWR Levee Log, 1992]. FS Date: 7/7/2016

36-inch concrete standpipe on LS toe.

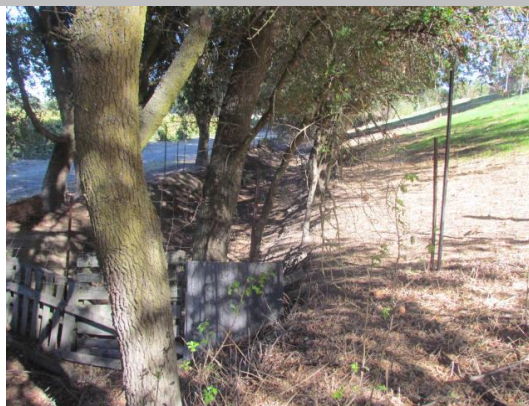
Photo 1 of 3 : SP_2018_RD0999_236_153_20180301_00071.jpg

LM Start	3.21	Rating **	M	Issue No.	153
LM End	4.22	Issue Type +	En	Location *	LS
Category	Earthen Levee			GPS Latitude/Longitude	
				Start	End
Item	Encroachments			38.364694 °	38.372513 °
				-121.560209 °	-121.552538 °
DWR ID	DWR_RD0999_05_f_2013_153				
Comment Code					
DT : Ditch					
Inspector Comment					
Adandoned irrigation ditch at landside toe.

Looking north at old irrigation ditch at landward toe.

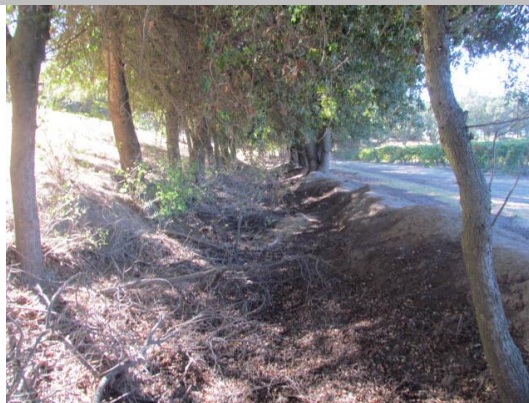
Photo 2 of 3 : SP_2018_RD0999_236_153_20180301_00072.jpg

LM Start	3.21	Rating **	M	Issue No.	153 (cont)
LM End	4.22	Issue Type +	En	Location *	LS

Looking south at irrigation ditch at landward toe.

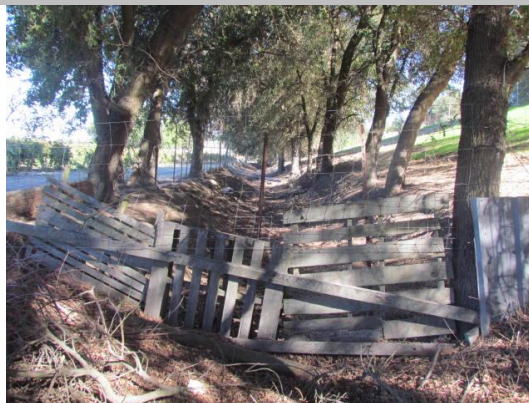
Photo 3 of 3 : SP_2018_RD0999_236_153_20180301_00073.jpg

LM Start	3.21	Rating **	M	Issue No.	153 (cont)	
LM End	4.22	Issue Type +	En	Location *	LS	
Category	Earthen Levee			GPS Latitude/Longitude		
				Start		End
Item	Encroachments			38.364694 °	38.372513 °	
				-121.560209 °	-121.552538 °	
DWR ID	DWR_RD0999_05_f_2013_153					
Comment Code						
DT : Ditch						
Inspector Comment						
Adandoned irrigation ditch at landside toe.

Looking north at irrigation ditch at landward toe.

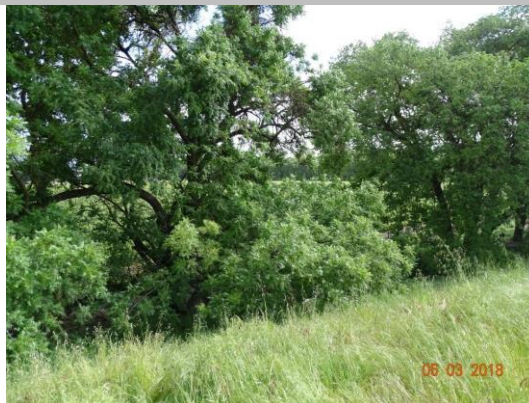
Photo 1 of 1 : SP_2018_RD0999_236_68_20180503_00197.jpg

LM Start	3.29	Rating **	M	Issue No.	68
LM End	3.29	Issue Type +	Ma	Location *	LS
Category	Earthen Levee			GPS Latitude/Longitude	
				Start	End
Item	Trim / Thin Trees			38.364341 °	38.364341 °
				-121.558928 °	-121.558928 °
DWR ID	DWR_RD0999_05_s_2018_68				
Comment Code					
T1 : Trim trees to at least five feet above ground level.					
Inspector Comment

Trim thin trees landside looking north.

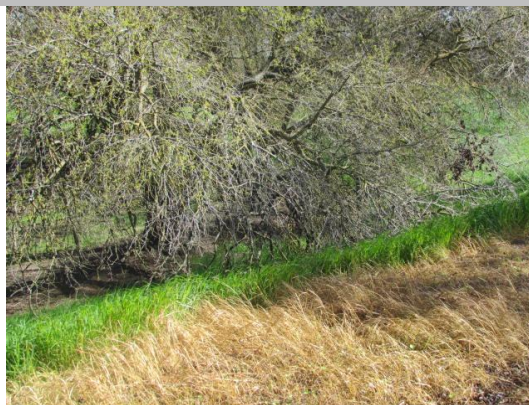
Photo 2 of 2 : SP_2018_RD0999_236_213_20180301_00117.jpg

LM Start	3.39	Rating **	U	Issue No.	213 (cont)
LM End	3.39	Issue Type +	Ma	Location *	LS

Looking northwest at untrimmed trees at landward toe. (Spring 2016)

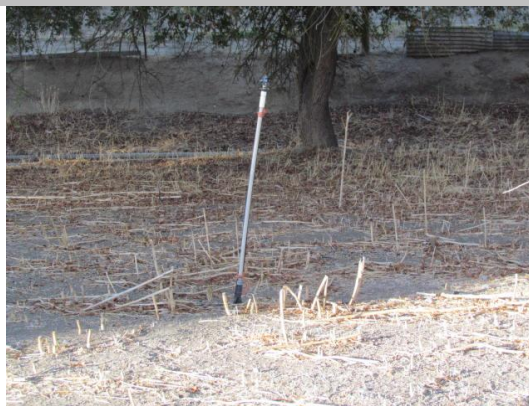
Photo 1 of 1 : SP_2018_RD0999_236_202_20180301_00113.jpg

LM Start	3.58	Rating **	M	Issue No.	202
LM End	3.64	Issue Type +	En	Location *	LS
Category	Earthen Levee			GPS Latitude/Longitude	
				Start	End
Item	Encroachments			38.366100 °	38.367043 °
				-121.556831 °	-121.556772 °
DWR ID	DWR_RD0999_05_f_2014_202				
Comment Code					
LI : Landscape Irrigation					
Inspector Comment					
Landowner installed sprinkler system on landside slope.

Looking west at one of several sprinklers installed on landward slope.

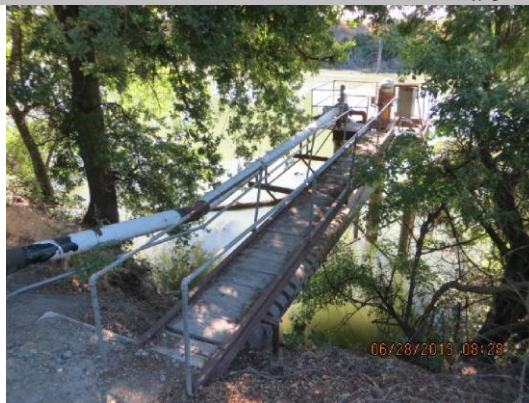
Photo 1 of 3 : UCIP_SP_2018_16337_27535.jpg

LM Start	3.67	Rating **	M	Issue No.	236
LM End	3.67	Issue Type +	En	Location *	
Category	Supplemental			GPS Latitude/Longitude	
				Start	End
Item	DWR UCIP Field Study			38.367469 °	38.367469 °
				-121.556509 °	-121.556509 °
DWR ID					
Comment Code					
Inspector Comment					
FS_ID:16337					
DS_ID:23965					
EP_NO: N/A					
Repair Type: Non-Urgent					
Crossing Status: Found					
UCIP Comments: Need to determine permit No. for this crossing.					
FIELD_STRUCT_DESC: 9-inch steel irrigation pipe through the levee, 2 feet below the crown. Pump on pier on the waterside (WS) with butterfly valve. Filter plant and siphon breaker on the landside (LS) toe. 1.5-inch galvanized iron electrical conduit at the same location.					
FS Date: 6/28/2013

Pump on pier at WS.

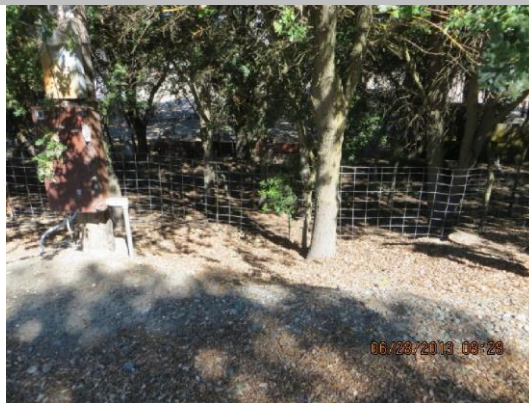
Photo 2 of 3 : UCIP_SP_2018_16337_27534.jpg

LM Start	3.67	Rating **	M	Issue No.	236 (cont)
LM End	3.67	Issue Type +	En	Location *

1.5-inch galvanized iron electrical conduit at same location.

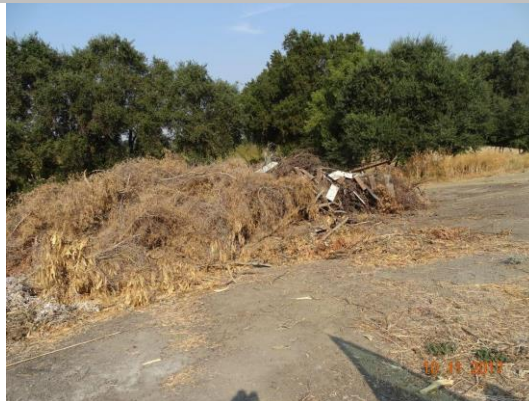
Photo 1 of 3 : SP_2018_RD0999_236_17_20180301_00015.jpg

LM Start	3.90	Rating **	U	Issue No.	17
LM End	3.90	Issue Type +	En	Location *	LS
Category	Earthen Levee			GPS Latitude/Longitude	
				Start	End
Item	Encroachments			38.368466 °	38.368466 °
				-121.552628 °	-121.552628 °
DWR ID	DWR_RD0999_05_s_2012_17				
Comment Code					
PR : Prunings					
Inspector Comment					
Large pruning pile on landside toe and slope.

Looking northwest at the landside slope.

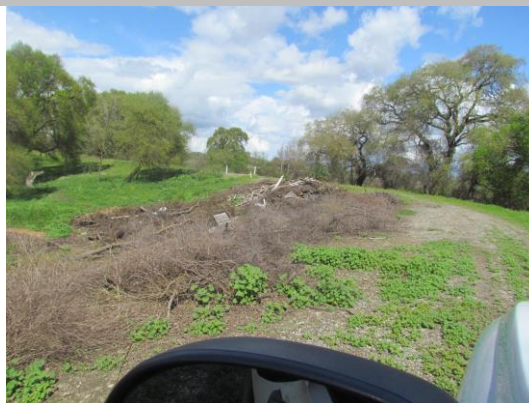
Photo 2 of 3 : SP_2018_RD0999_236_17_20180301_00016.jpg

LM Start	3.90	Rating **	U	Issue No.	17 (cont)
LM End	3.90	Issue Type +	En	Location *	LS

Looking northwest at large pruning pile on landward slope. (Spring 2017)

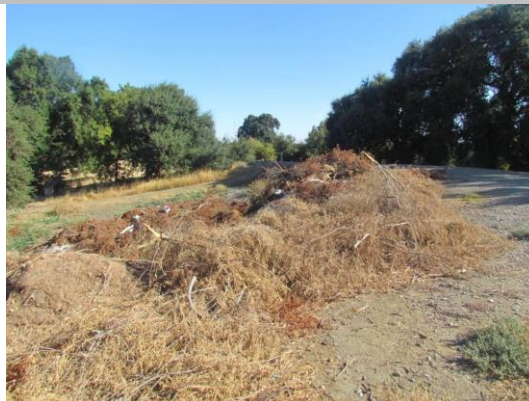
Photo 3 of 3 : SP_2018_RD0999_236_17_20180301_00017.jpg

LM Start	3.90	Rating **	U	Issue No.	17 (cont)
LM End	3.90	Issue Type +	En	Location *	LS

Looking northwest at large pruning pile on landward slope. (Fall 2016)

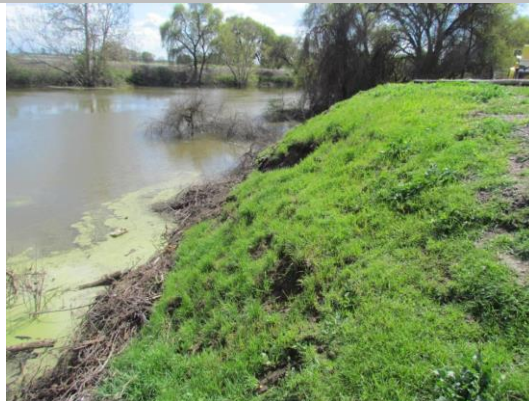
Photo 1 of 2 : SP_2018_RD0999_236_12_20180301_00009.jpg

LM Start	4.25	Rating **	U	Issue No.	12
LM End	4.25	Issue Type +	Ma	Location *	WS
Category	Earthen Levee			GPS Latitude/Longitude	
				Start	End
Item	Slope Stability			38.372872 °	38.372872 °
				-121.552185 °	-121.552185 °
DWR ID	DWR_RD0999_05_s_2017_12				
Comment Code					
S1 : Repair slope instability.					
Inspector Comment					
Large slough on waterside slope.

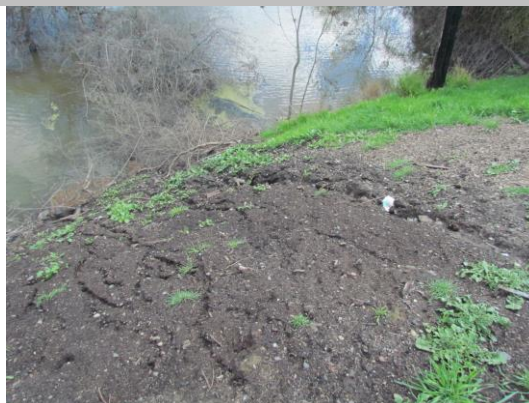
Photo 2 of 2 : SP_2018_RD0999_236_12_20180301_00010.jpg

Looking downstream at finger erosion on downstream side of slough.

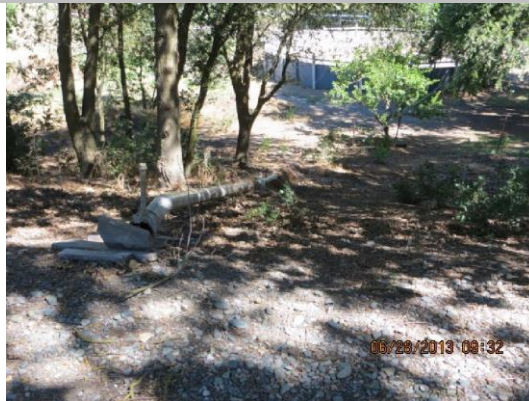
Photo 1 of 3 : UCIP_SP_2018_16403_27686.jpg

LM Start	4.45	Rating **	M	Issue No.	238
LM End	4.45	Issue Type +	En	Location *	
Category	Supplemental			GPS Latitude/Longitude	
				Start	End
Item	DWR UCIP Field Study			38.375036 °	38.375036 °
				-121.549961 °	-121.549961 °
DWR ID					
Comment Code					
Inspector Comment					
FS_ID:16403 DS_ID:23967 EP_NO: N/A Repair Type: Non-Urgent Crossing Status: Found UCIP Comments: Need to determine Permit No. for this crossing or remove it. FIELD_STRUCT_DESC: 5-inch temporary aluminum irrigation pipe over the top of the levee. Portable pump on the waterside (WS) toe. FS Date: 6/28/2013

Pipe on LS slope.

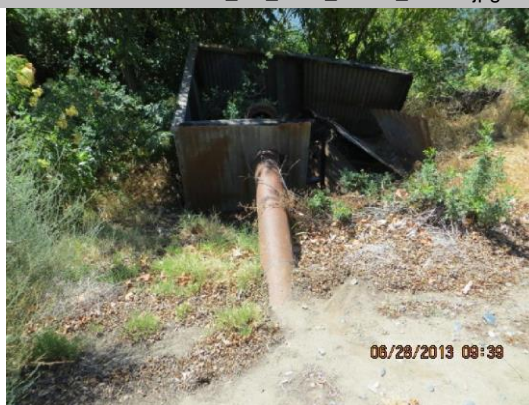
Photo 1 of 3 : UCIP_SP_2018_15443_25362.jpg

Comment Code					
Inspector Comment					
FS_ID:15443 DS_ID:22882 EP_NO: 7383 Repair Type: Non-Urgent Crossing Status: Found UCIP Comments: Pipe abandoned and should be done so properly. FIELD_STRUCT_DESC: 10-inch steel irrigation pipe through the levee, 4 feet below the crown. Pump house on the waterside (WS) slope, and a joint pole (JP) on the landside (LS) shoulder. 1.5-inch galvanized iron electrical conduit at the same location. Replaces an existing portion of a 10-inch pipe within the levee section. (Permit No. 7383, 1971 - Monticello Vineyards). [Additional Reference(s): USACE Sacramento O&M Manual 113 (Revised), October 1966, (HLM 4.84)]. FS Date: 6/28/2013

Abandoned pumphouse on WS slope.

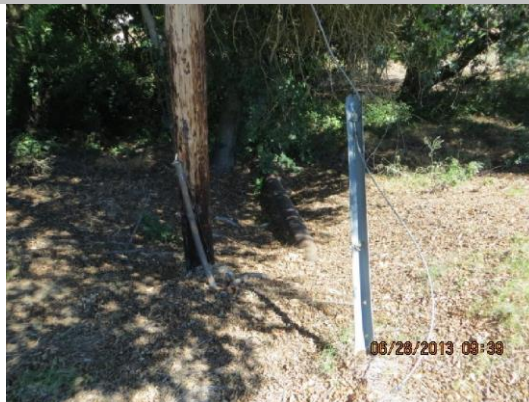
Photo 3 of 3 : UCIP_SP_2018_15443_25360.jpg

Pipe visible on LS slope.

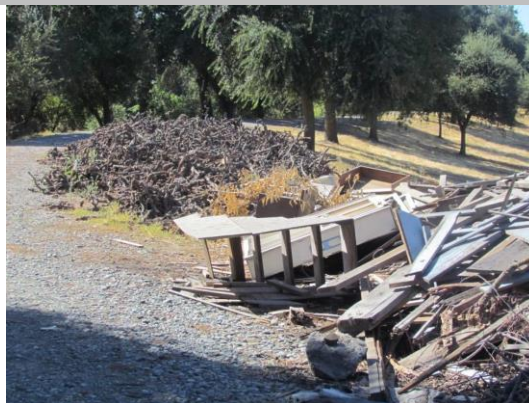
Photo 1 of 2 : SP_2018_RD0999_236_65_20180301_00035.jpg

LM Start	5.07	Rating **	M	Issue No.	65
LM End	5.07	Issue Type +	En	Location *	LS
Category	Earthen Levee			GPS Latitude/Longitude	
				Start	End
Item	Encroachments			38.379711 °	38.379711 °
				-121.541070 °	-121.541070 °
DWR ID	DWR_RD0999_05_s_2012_65				
Comment Code					
PR : Prunings					
Inspector Comment					
Prunings and garbage pile on landside shoulder and slope.

Looking south at prunings and garbage on landward shoulder and slope. (Fall 2016)

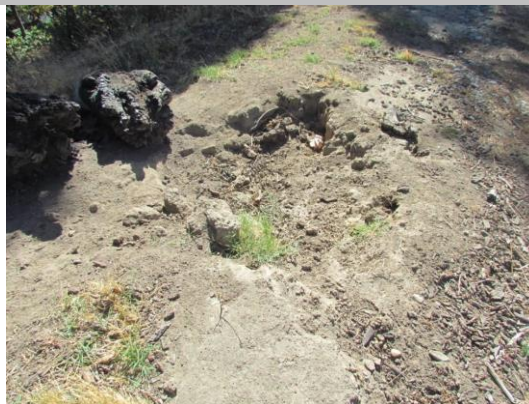
Photo 1 of 3 : SP_2018_RD0999_236_176_20180301_00097.jpg

LM Start	5.12	Rating **	U	Issue No.	176
LM End	5.12	Issue Type +	Ma	Location *	WS
Category	Earthen Levee			GPS Latitude/Longitude	
				Start	End
Item	Slope Stability			38.380420 °	38.380420 °
				-121.541102 °	-121.541102 °
DWR ID	DWR_RD0999_05_f_2015_176				
Comment Code					
S1 : Repair slope instability.					
Inspector Comment					
Large hole on waterside shoulder caused by fallen tree.

Looking at hole from falling tree on waterward shoulder. (Fall 2016)

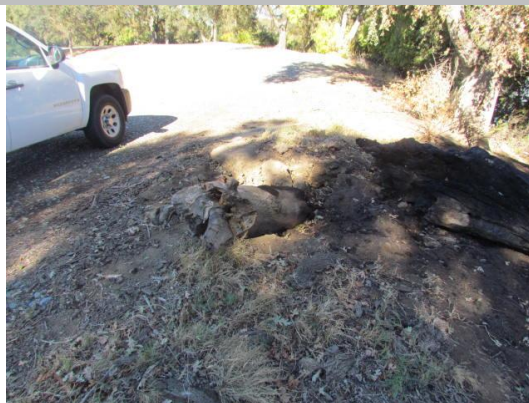
Photo 2 of 3 : SP_2018_RD0999_236_176_20180301_00098.jpg

LM Start	5.12	Rating **	U	Issue No.	176 (cont)	
LM End	5.12	Issue Type +	Ma	Location *	WS	
Category	Earthen Levee			GPS Latitude/Longitude		
				Start		End
Item	Slope Stability			38.380420 °		38.380420 °
				-121.541102 °		-121.541102 °
DWR ID	DWR_RD0999_05_f_2015_176					
Comment Code						
S1 : Repair slope instability.						
Inspector Comment						
Large hole on waterside shoulder caused by fallen tree.

Looking at hole on waterward shoulder caused by fallen tree.

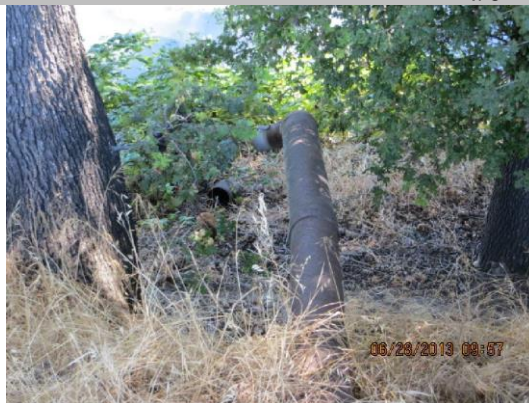
Photo 1 of 3 : UCIP_SP_2018_50094_25396.jpg

Comment Code					
Inspector Comment					
FS_ID:50094 DS_ID:22856 EP_NO: N/A Repair Type: Urgent Crossing Status: Found UCIP Comments: 07/07/2016 - Pipe open on WS. no pipe or appurtenances visible on LS. pipe on WS slope below open penetration noted. May have previously been connected. (T. Hatch/UCIP)06/28/2013 - Pipe abandoned and should be done so properly. Pipe open on waterside. (W. Wylie/UCIP) FIELD_STRUCT_DESC: *ABANDONED* 7-inch steel irrigation pipe through the levee, 6.5 feet below the crown. [Additional Reference(s): DWR Levee Log, 1992. USACE Sacramento O&M Manual 113 (Revised), October 1966, (HLM 5.31) (8-inch pipe listed)]. FS Date: 7/7/2016

Pipe open on WS slope.

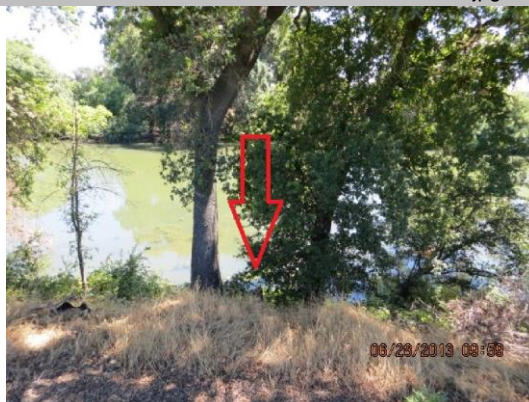
Photo 2 of 3 : UCIP_SP_2018_50094_25395.jpg

Pipe visible on WS slope.

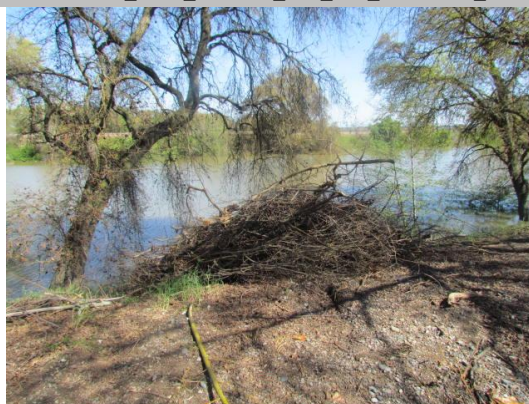
Photo 1 of 1 : SP_2018_RD0999_236_214_20180301_00118.jpg

LM Start	5.31	Rating **	M	Issue No.	214
LM End	5.31	Issue Type +	Ma	Location *	WS
Category	Earthen Levee			GPS Latitude/Longitude	
				Start	End
Item	Encroachments			38.381178 °	38.381178 °
				-121.544193 °	-121.544193 °
DWR ID	DWR_RD0999_05_s_2016_214				
Comment Code					
PR : Prunings					
Inspector Comment					
Pruning pile on waterside slope.

Looking southeast at prunings on waterward shoulder.

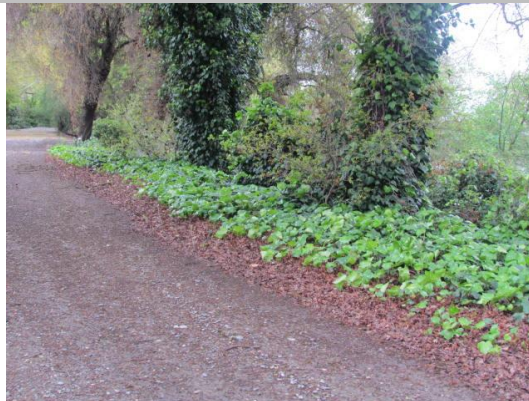
Photo 2 of 2 : SP_2018_RD0999_236_43_20180301_00027.jpg

LM Start	5.42	Rating **	U	Issue No.	43 (cont)	
LM End	5.44	Issue Type +	En	Location *	WS	
Category	Earthen Levee			GPS Latitude/Longitude		
				Start		End
Item	Vegetation			38.381815 °		38.382137 °
				-121.546058 °		-121.546338 °
DWR ID	DWR_RD0999_05_s_2012_43					
Comment Code						
V6 : Landscaping						
Inspector Comment						
Ground cover blocking view of waterside slope.

Looking northeast at dense groundcover and vegetation on waterside slope.

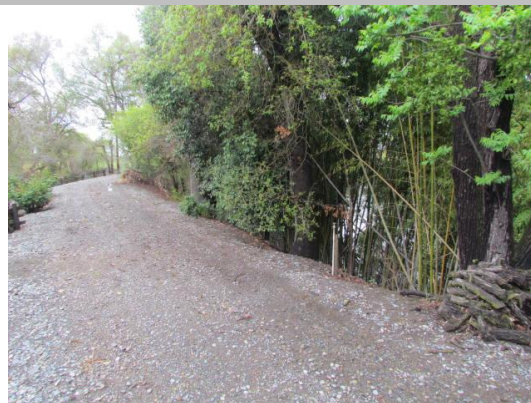
Photo 1 of 1 : SP_2018_RD0999_236_71_20180301_00039.jpg

LM Start	5.50	Rating **	U	Issue No.	71
LM End	5.55	Issue Type +	Ma	Location *	WS
Category	Earthen Levee			GPS Latitude/Longitude	
				Start	End
Item	Vegetation			38.382790 °	38.383548 °
				-121.546754 °	-121.546728 °
DWR ID	DWR_RD0999_05_s_2012_71				
Comment Code					
V2 : Remove the wild growth other than native grasses from the levee slopes.					
Inspector Comment

Looking northeast at dense vegetation on waterside slope.

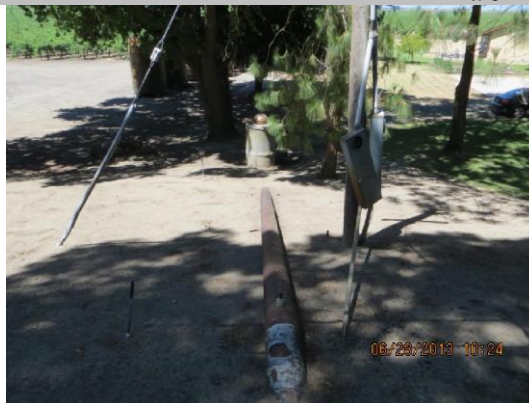
Photo 1 of 3 : UCIP_SP_2018_15446_25366.jpg

Comment Code					
Inspector Comment					
FS_ID:15446 DS_ID:22857 EP_NO: N/A Repair Type: Non-Urgent Crossing Status: Found UCIP Comments: Pipe appears abandoned and should be done so appropriately. FIELD_STRUCT_DESC: 10-inch steel irrigation pipe through the levee, 4 feet below the crown. Pump house and gate valve on the waterside (WS) slope. Vent on the landside (LS) slope, and a 42-inch concrete standpipe on the LS toe. Service pole on the LS slope with a 1.5-inch galvanized iron electrical conduit at the same location. [Additional Reference(s): DWR Levee Log, 1992. USACE Sacramento O&M Manual 113 (Revised), October 1966, (HLM 5.66) (8-inch pipe listed)]. FS Date: 6/28/2013

Pipe visible on LS slope with JP, Meter and electrical conduit, and concrete standpipe,

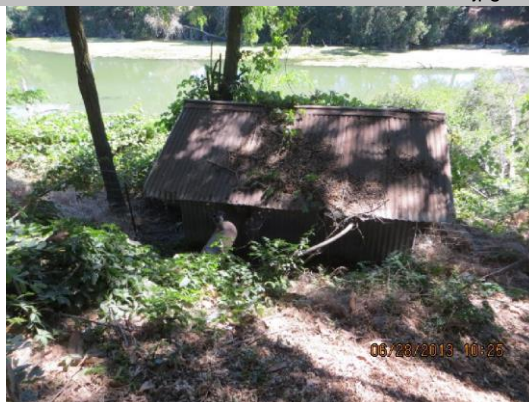
Photo 2 of 3 : UCIP_SP_2018_15446_25365.jpg

Corrugated metal pump house on WS slope.

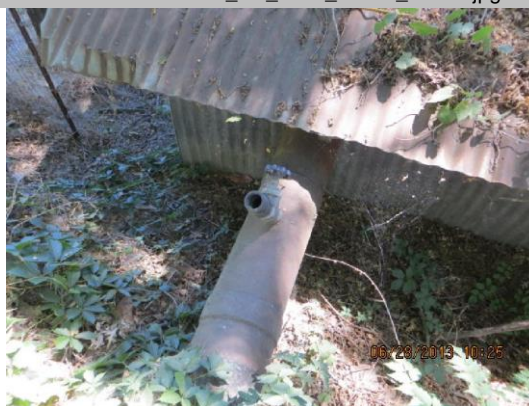
Photo 3 of 3 : UCIP_SP_2018_15446_25364.jpg

Comment Code						
Inspector Comment						
FS_ID:15446 DS_ID:22857 EP_NO: N/A Repair Type: Non-Urgent Crossing Status: Found UCIP Comments: Pipe appears abandoned and should be done so appropriately. FIELD_STRUCT_DESC: 10-inch steel irrigation pipe through the levee, 4 feet below the crown. Pump house and gate valve on the waterside (WS) slope. Vent on the landside (LS) slope, and a 42-inch concrete standpipe on the LS toe. Service pole on the LS slope with a 1.5-inch galvanized iron electrical conduit at the same location. [Additional Reference(s): DWR Levee Log, 1992. USACE Sacramento O&M Manual 113 (Revised), October 1966, (HLM 5.66) (8-inch pipe listed)]. FS Date: 6/28/2013

Vent on pipe at WS shoulder.

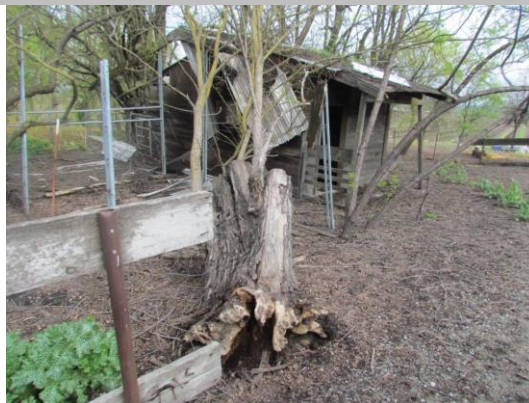
Photo 1 of 2 : SP_2018_RD0999_236_37_20180301_00024.jpg

LM Start	5.57	Rating **	U	Issue No.	37
LM End	5.57	Issue Type +	En	Location *	LS
Category	Earthen Levee			GPS Latitude/Longitude	
				Start	End
Item	Encroachments			38.383780 °	38.383780 °
				-121.546590 °	-121.546590 °
DWR ID	DWR_RD0999_05_s_2017_37				
Comment Code					
BU : Building					
Inspector Comment					
Dilapidated horse pen on landside slope and fallen tree.

Looking northwest at dilapidated horse pen and fallen tree on landward slope.

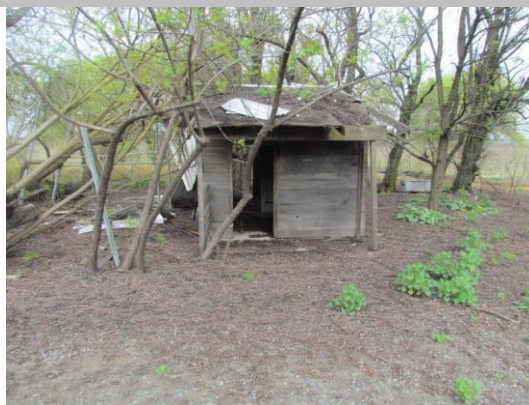
Photo 2 of 2 : SP_2018_RD0999_236_37_20180301_00025.jpg

Looking west at dilapidated horse pen and fallen tree on landward slope.

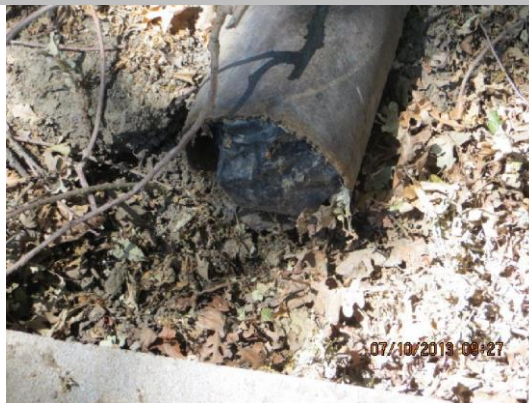
Photo 3 of 3 : UCIP_SP_2018_50095_25857.jpg

Pipe open on WS slope.

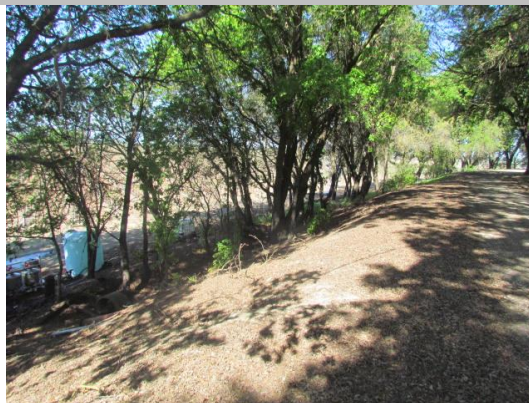
Photo 1 of 1 : SP_2018_RD0999_236_60_20180301_00034.jpg

LM Start	6.13	Rating **	M	Issue No.	60
LM End	6.13	Issue Type +	Ma	Location *	LS
Category	Earthen Levee			GPS Latitude/Longitude	
				Start	End
Item	Trim / Thin Trees			38.388225 °	38.388225 °
				-121.542697 °	-121.542697 °
DWR ID	DWR_RD0999_05_s_2012_60				
Comment Code					
T3 : Trim and thin trees to allow visibility of the ground and room to flood fight.					
Inspector Comment

Looking north at dense trees on landward slope. (Spring 2015)

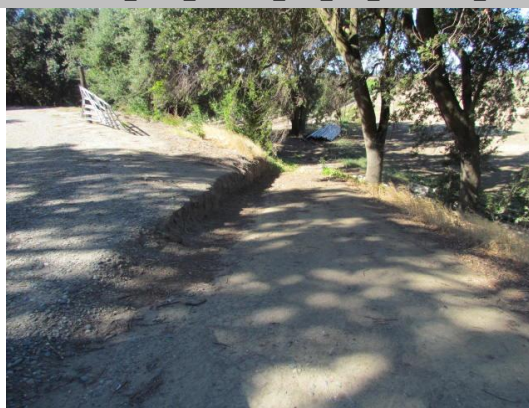
Photo 1 of 1 : SP_2018_RD0999_236_155_20180301_00074.jpg

LM Start	6.26	Rating **	M	Issue No.	155
LM End	6.26	Issue Type +	En	Location *	LS
Category	Earthen Levee			GPS Latitude/Longitude	
				Start	End
Item	Encroachments			38.389946 °	38.389946 °
				-121.542461 °	-121.542461 °
DWR ID	DWR_RD0999_05_f_2013_155				
Comment Code					
RA : Ramp					
Inspector Comment					
Unauthorized ramp on landside slope.

Looking southwest at ramp on landward slope.

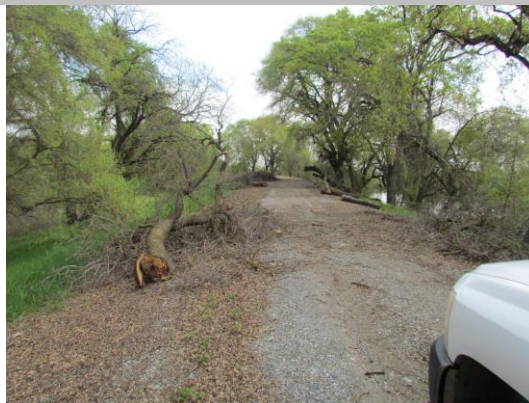
Photo 1 of 2 : SP_2018_RD0999_236_92_20180301_00045.jpg

LM Start	6.43	Rating **	M	Issue No.	92
LM End	6.48	Issue Type +	Ma	Location *	LS
Category	Earthen Levee			GPS Latitude/Longitude	
				Start	End
Item	Encroachments			38.391355 °	38.391776 °
				-121.540113 °	-121.539295 °
DWR ID	DWR_RD0999_05_s_2012_92				
Comment Code					
PR : Prunings					
Inspector Comment					
Large pruning piles and fallen tree on waterside and landside shoulder and slope.

Looking east at fallen tree and pruning on landward and waterward shoulder and slope.

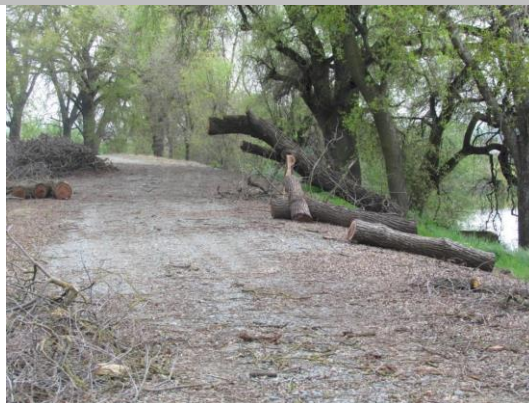
Photo 2 of 2 : SP_2018_RD0999_236_92_20180301_00046.jpg

LM Start	6.43	Rating **	M	Issue No.	92 (cont)	
LM End	6.48	Issue Type +	Ma	Location *	LS	
Category	Earthen Levee			GPS Latitude/Longitude		
				Start		End
Item	Encroachments			38.391355 °		38.391776 °
				-121.540113 °		-121.539295 °
DWR ID	DWR_RD0999_05_s_2012_92					
Comment Code						
PR : Prunings						
Inspector Comment						
Large pruning piles and fallen tree on waterside and landside shoulder and slope.

Looking east at tree branches and limbs on waterward and landward shoulder and slope.

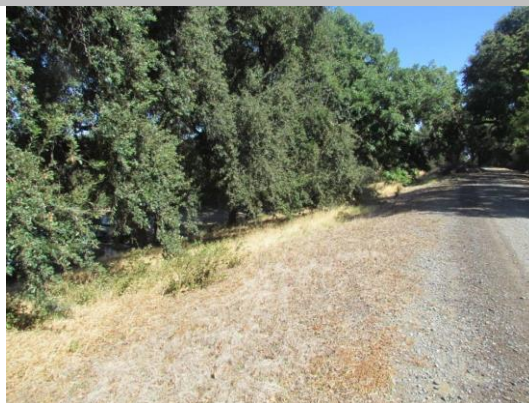
Photo 1 of 1 : SP_2018_RD0999_236_181_20180301_00100.jpg

LM Start	6.44	Rating **	M	Issue No.	181
LM End	6.44	Issue Type +	Ma	Location *	LS
Category	Earthen Levee			GPS Latitude/Longitude	
				Start	End
Item	Trim / Thin Trees			38.391502 °	38.391502 °
				-121.539897 °	-121.539897 °
DWR ID	DWR_RD0999_05_f_2015_181				
Comment Code					
T1 : Trim trees to at least five feet above ground level.					
Inspector Comment					
Untrimmed trees on landside slope and toe.

Looking northwest at untrimmed trees on landward slope and toe.

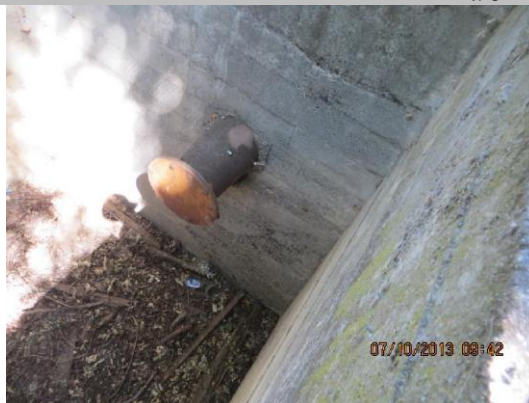
Photo 1 of 2 : UCIP_SP_2018_15604_25875.jpg

LM Start	6.47	Rating **	M	Issue No.	245
LM End	6.47	Issue Type +	En	Location *	
Category	Supplemental			GPS Latitude/Longitude	
				Start	End
Item	DWR UCIP Field Study			38.391723 °	38.391723 °
				-121.539442 °	-121.539442 °
DWR ID					
Comment Code					
Inspector Comment					
FS_ID:15604 DS_ID:22860 EP_NO: N/A Repair Type: Non-Urgent Crossing Status: Found UCIP Comments: Pipe abandoned and should be done so properly. FIELD_STRUCT_DESC: *ABANDONED* 14-inch steel drainage pipe through the levee, 7.2 feet below the crown. Open 9-foot by 14-foot concrete pump pit on the waterside (WS) slope. Pipe has steel plate bolted over the WS end. [Additional Reference(s): DWR Levee Log, 1992. USACE Sacramento O&M Manual 113 (Revised), October 1966, (HLM 6.61)]. FS Date: 7/10/2013

Pipe with steel plate bolted over opening at concrete pump pit on WS toe.

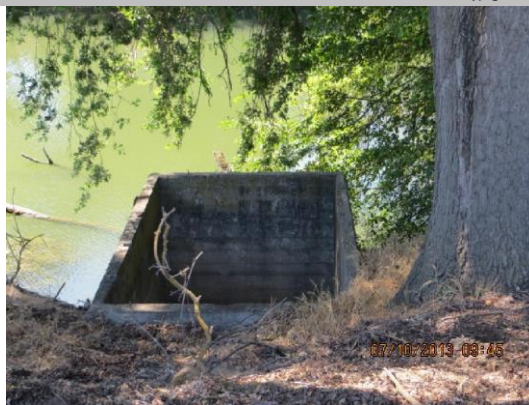
Photo 2 of 2 : UCIP_SP_2018_15604_25874.jpg

Concrete pump pit on WS slope.

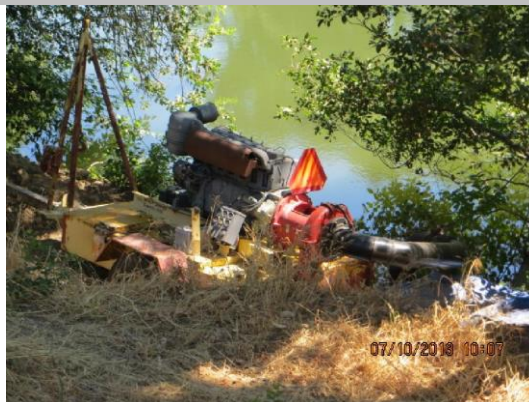
Photo 2 of 2 : UCIP_SP_2018_16342_27543.jpg

Portable pump on WS toe.

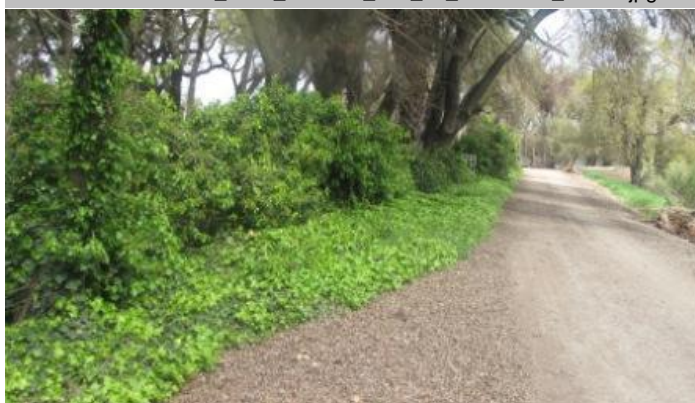
Photo 1 of 2 : SP_2018_RD0999_236_93_20180301_00047.jpg

LM Start	6.68	Rating **	U	Issue No.	93
LM End	6.71	Issue Type +	En	Location *	LS
Category	Earthen Levee			GPS Latitude/Longitude	
				Start	End
Item	Vegetation			38.394491 °	38.394991 °
				-121.539427 °	-121.539333 °
DWR ID	DWR_RD0999_05_s_2012_93				
Comment Code					
V6 : Landscaping					
Inspector Comment					
Dense landscaping on landside slope.

Looking north at overgrown landscape on landside slope and toe.

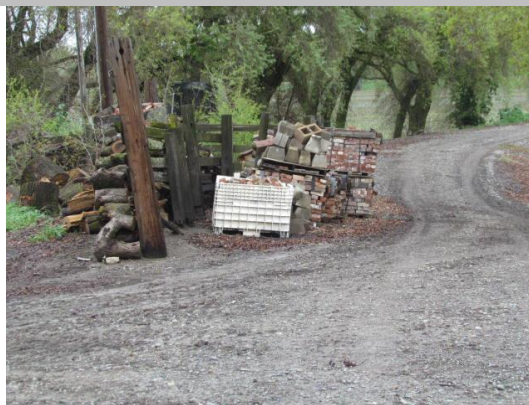
Photo 2 of 4 : SP_2018_RD0999_236_96_20180301_00050.jpg

Looking northeast at firewood and other material on landside shoulder.
(Spring 2012)
